PHOTOGRAPHIC LOG

PHOTOGRAPH LOG ROLL 10
AMERICAN CHEMICAL SERVICES

ROLL #11 PHOTOGRAPH LOG
AMERICAN CHEMICAL SERVICES
12 March to 16 March 1990

ROLL #12 PHOTOGRAPH LOG
AMERICAN CHEMICAL SERVICES
19 MARCH TO 26 MARCH 1990

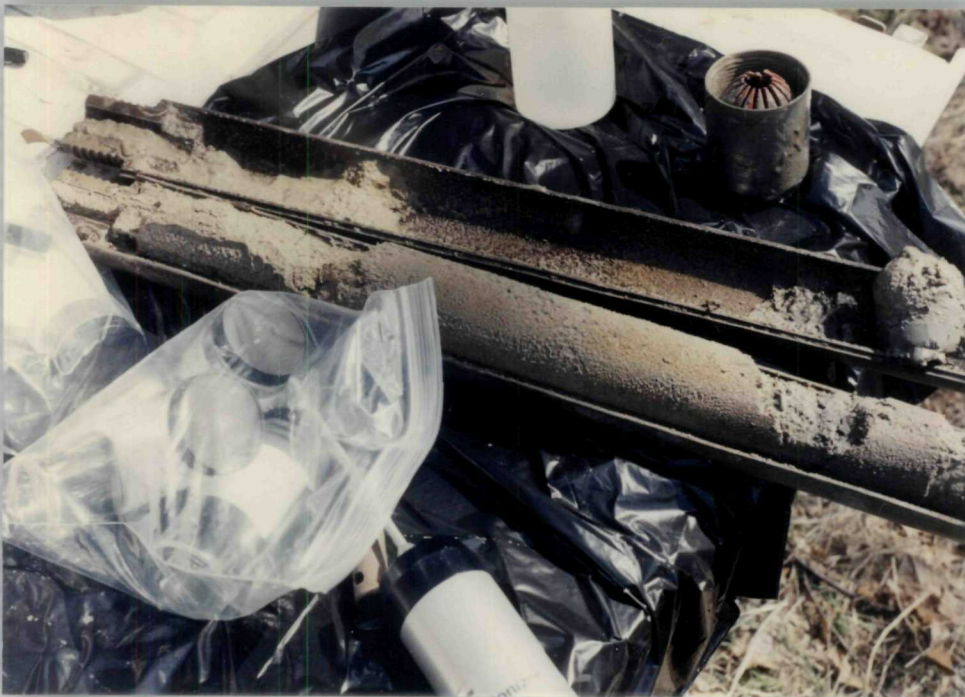
| Photo | Description | Date |
|---|---|---|
| R17-10 | Location of soil boring AM-02 | 5/2/90 |

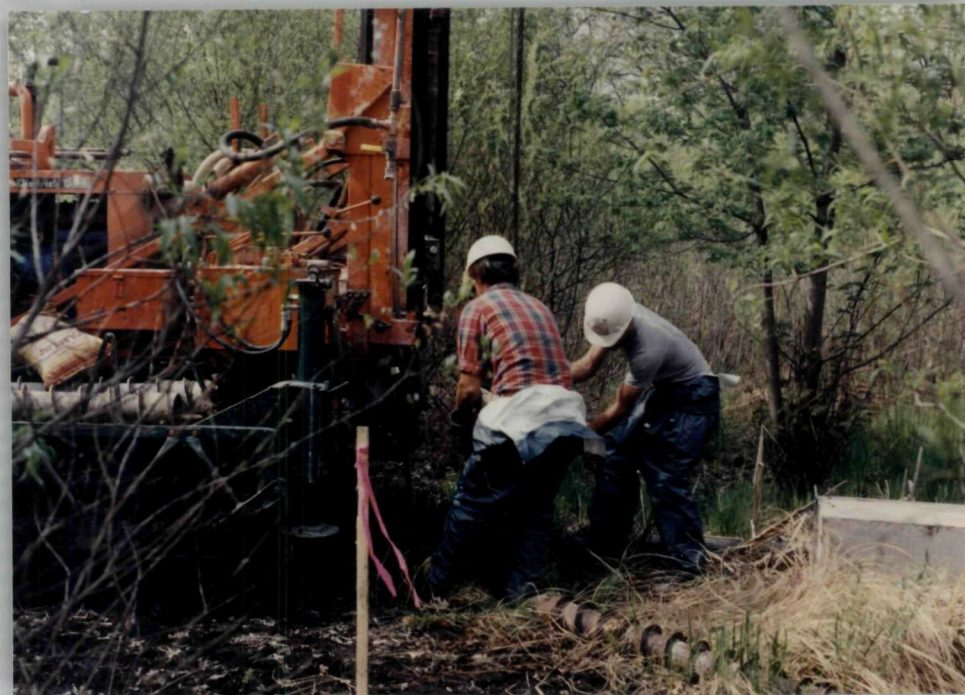
| Photo | Description | Date |
|---|---|---|
| R17-9 | Split spoon sample, boring AM-01, 8 to 10 feet | 5/2/90 |

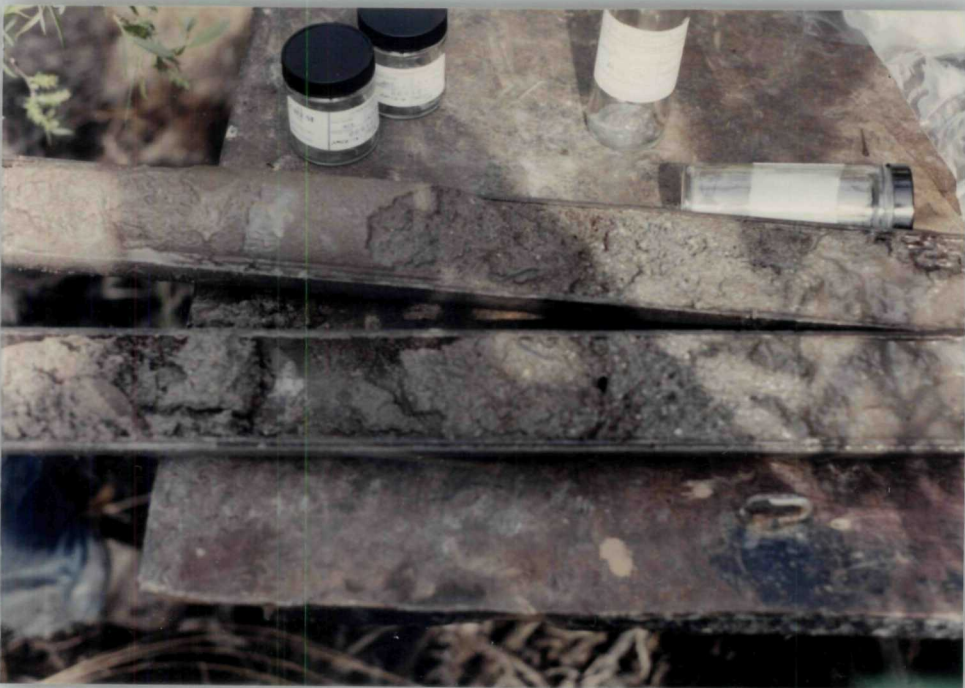
| Photo | Description | Date |
|---|---|---|
| R17-11 | Split spoon sample, boring AM-02, 10 to 12 feet | 5/2/90 |

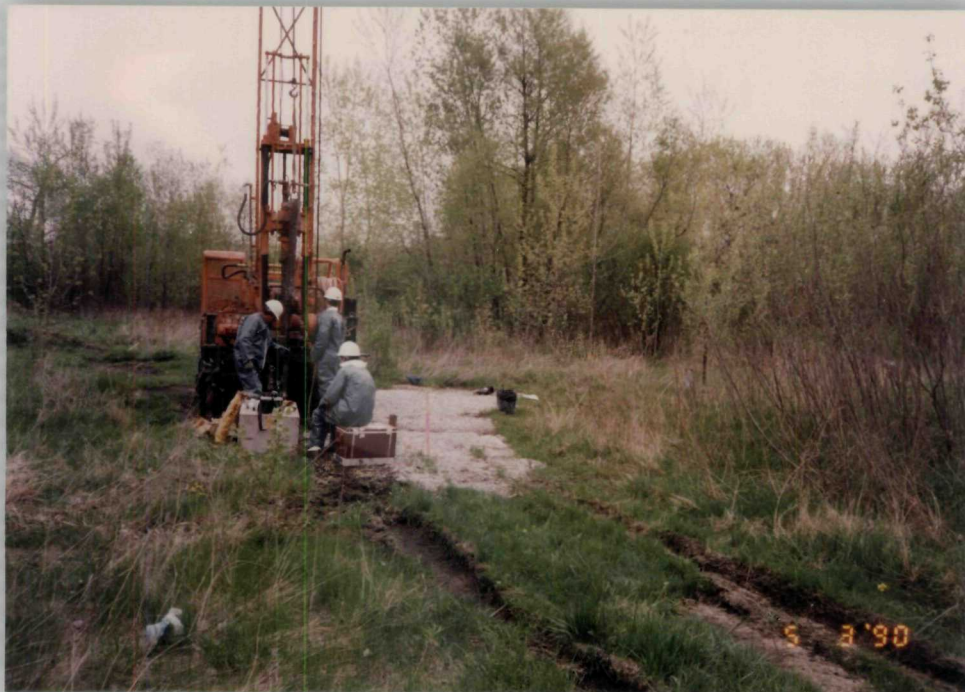
| Photo | Description | Date |
|---|---|---|
| R18-02 | Split spoon sample, boring AM-05, 10 to 12 feet | 5/3/90 |

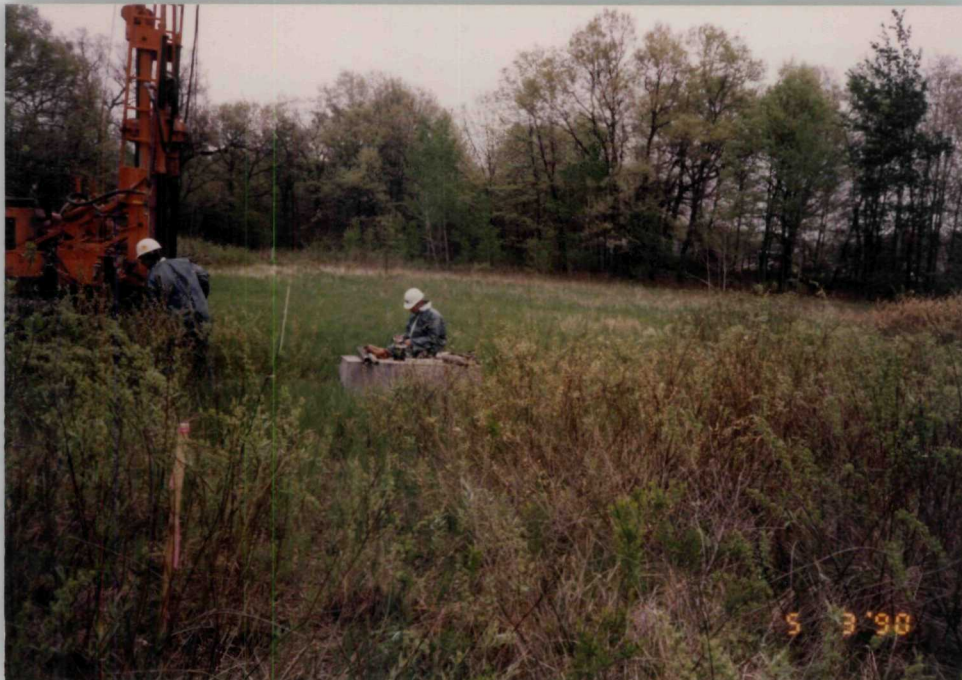
| Photo | Description | Date |
|---|---|---|
| R18-04 | Split spoon sample, boring AM-04, 10 to 12 feet | 5/3/90 |

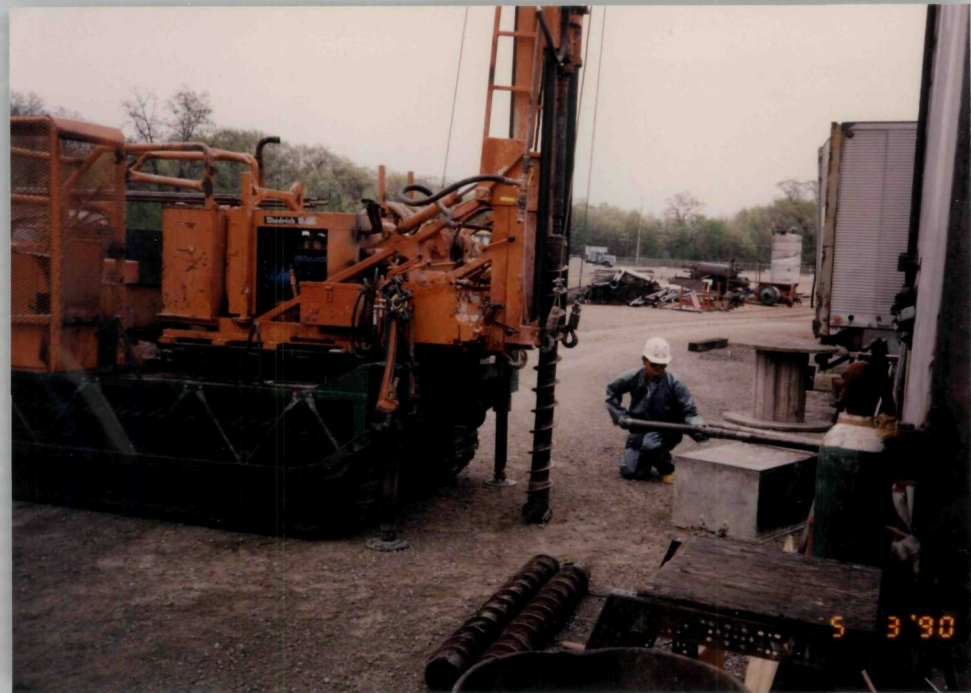
| Photo | Description | Date |
|---|---|---|
| R18-05 | Split spoon sample, boring AM-04, 10 to 12 feet | 5/3/90 |

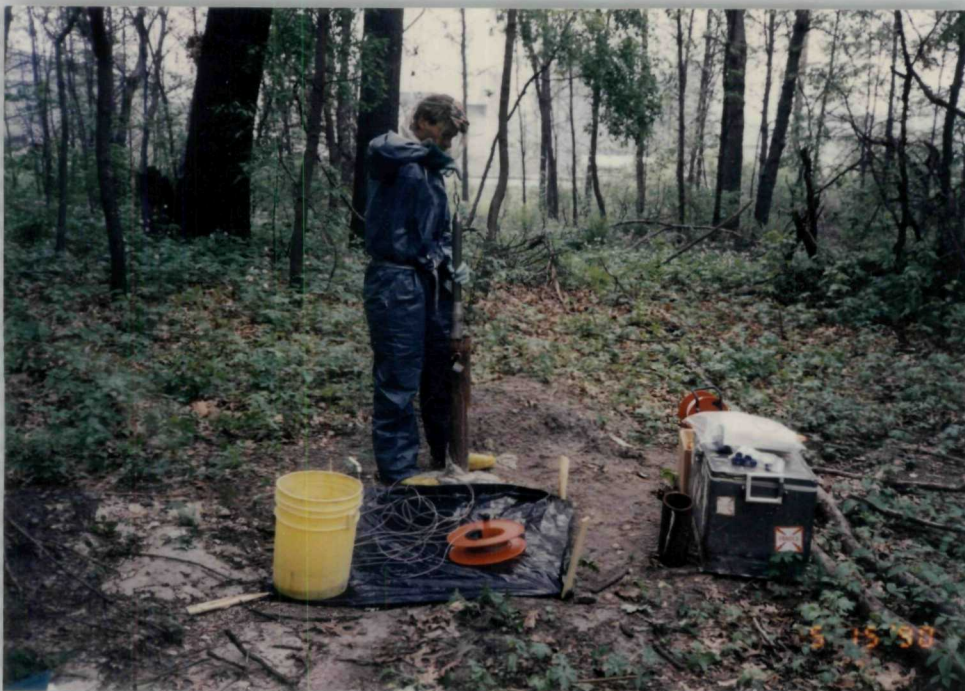
| Photo | Description | Date |
|---|--|---|
| R20-2 | Tim Maley filtering sample from MW-07 | 5/15/90 |

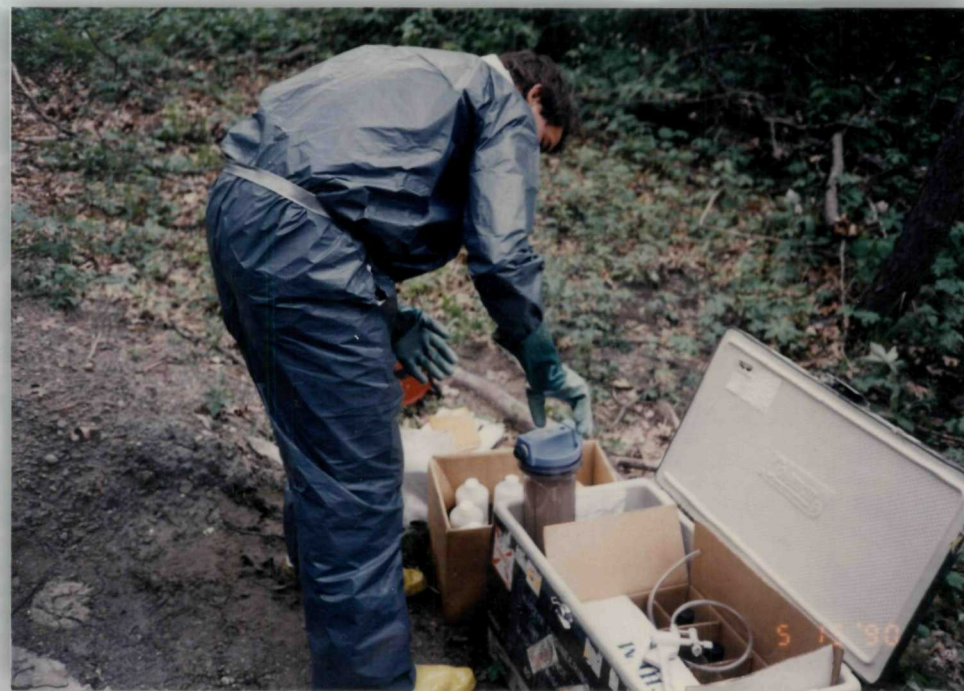
| Photo | Description | Date |
|---|--|---|
| R20-1 | Tim Maley (WEI) purging MW-07 | 5/15/90 |

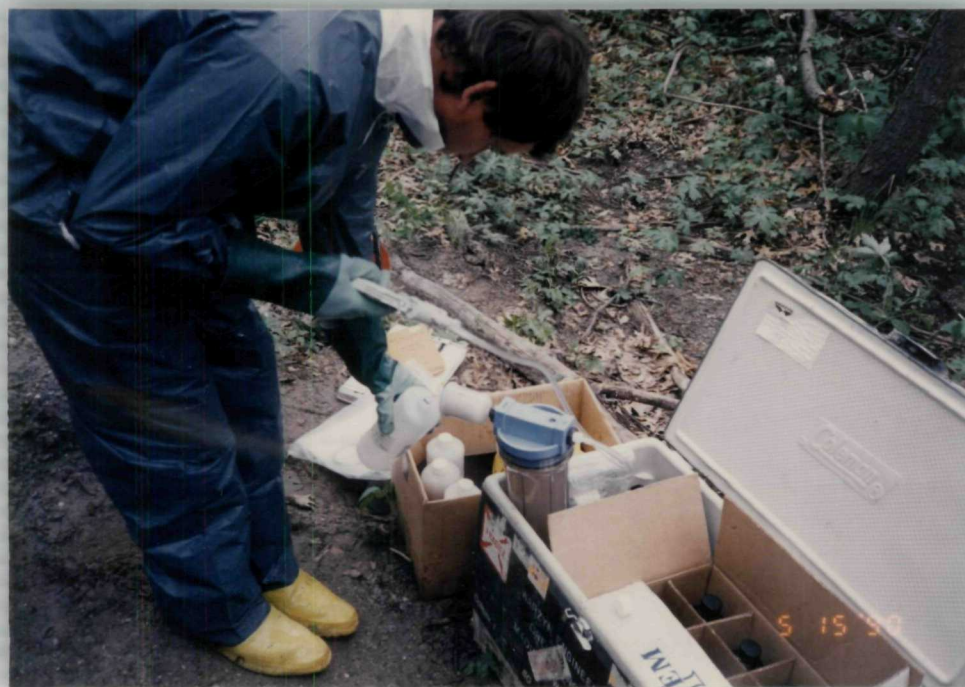
| Photo | Description | Date |
|---|--|---|
| R20-4 | Field parameters sample being measured for MW-07 | 5/15/90 |

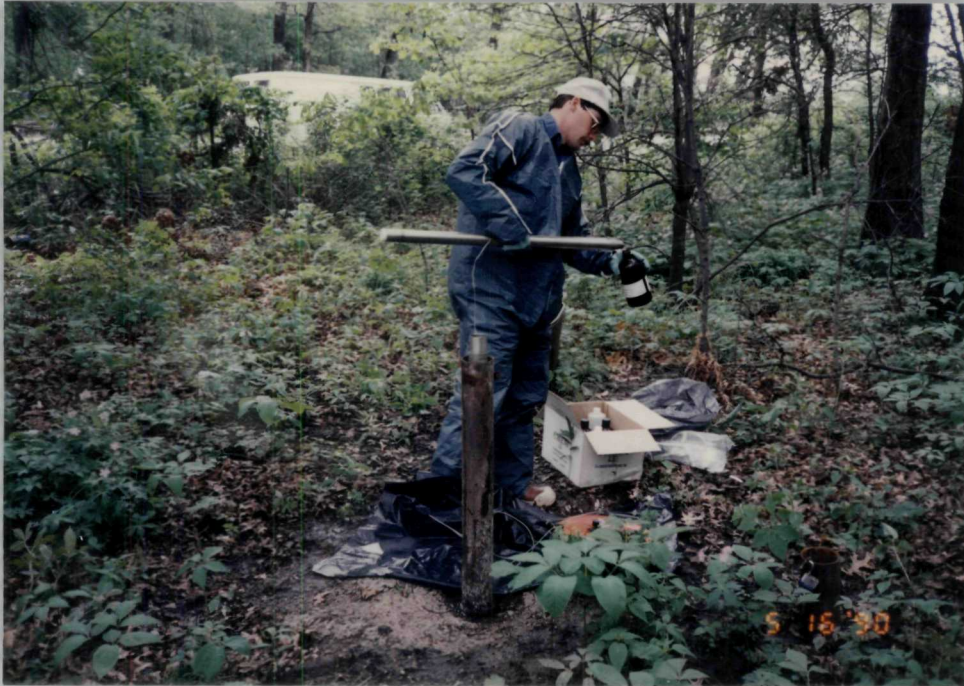
| Photo | Description | Date |
|---|--|---|
| R20-6 | Filtering sample from MW-13S | 5/16/90 |

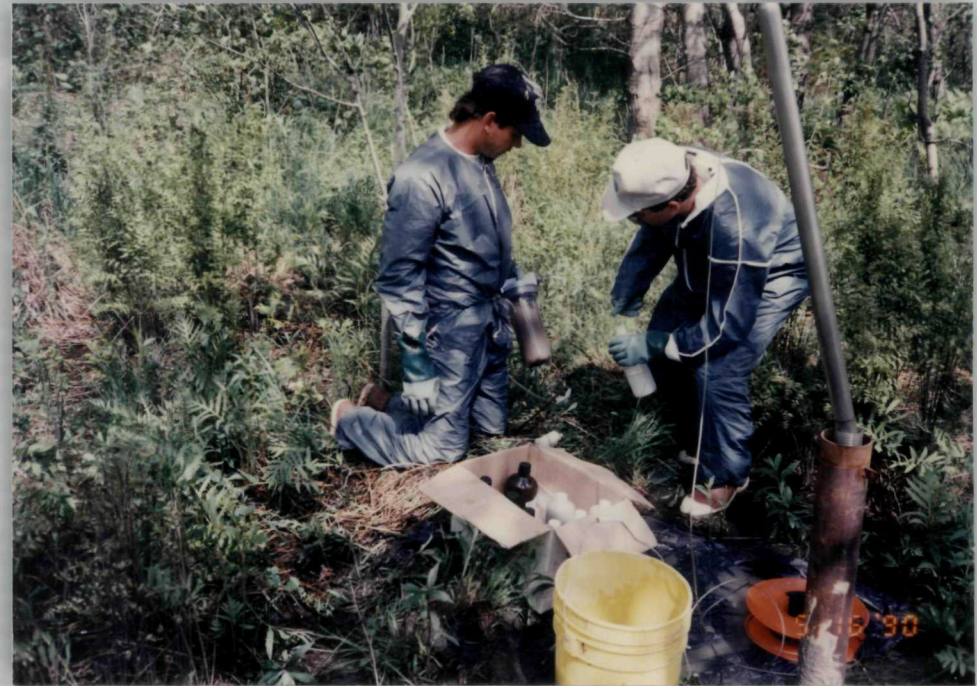
| Photo | Description | Date |
|---|--|---|
| R20-5 | Tom Dushek (WEI) sampling MW-11S | 5/16/90 |

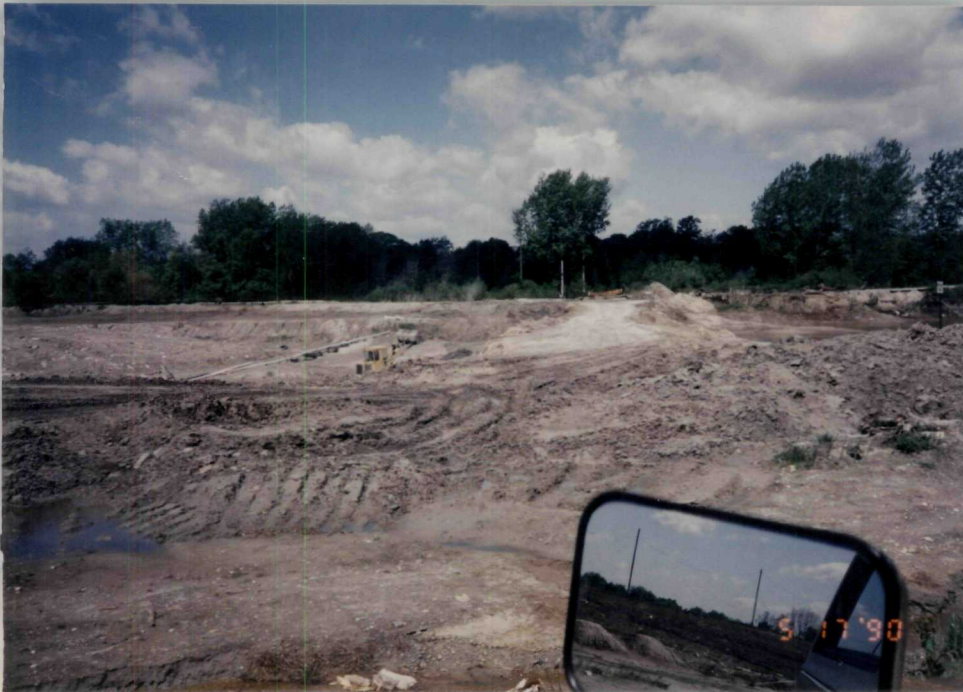
| Photo | Description | Date |
|---|--|---|
| R20-10 | Bulldozer removing clay in excavation at Griffith Landfill | 5/17/90 |
